~~Bayard Farm~~ CHESAPEAKE FARMS
CE-1049
Near Cayots Corner
Private

C. 1830, 1860

CE-1049

INVENTORY FORM FOR STATE HISTORIC SITES SURVEY

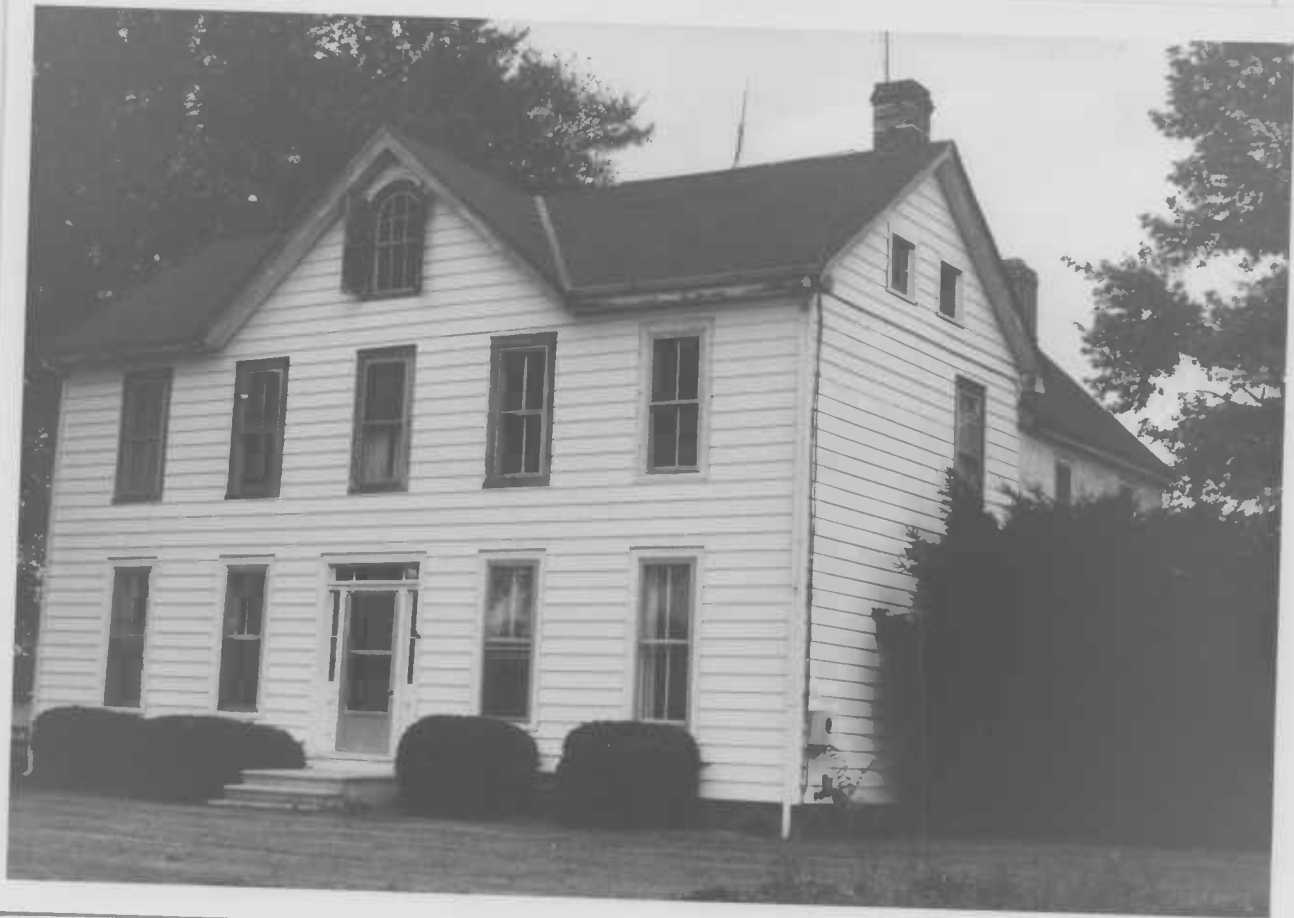
EAST ELEVATION

The east facade is five bays across with a central entrance and corresponding 2/2 sash windows. The four panel front door has arched top panels. It is bordered by two light sidelights and a three light transom. The window surrounds have been covered with aluminum. Five 2/2 sash windows illuminate the second floor and a arched 6/6 light with louvered shutters lights the cross gable. The eaves are typically extended with soffits sloped.

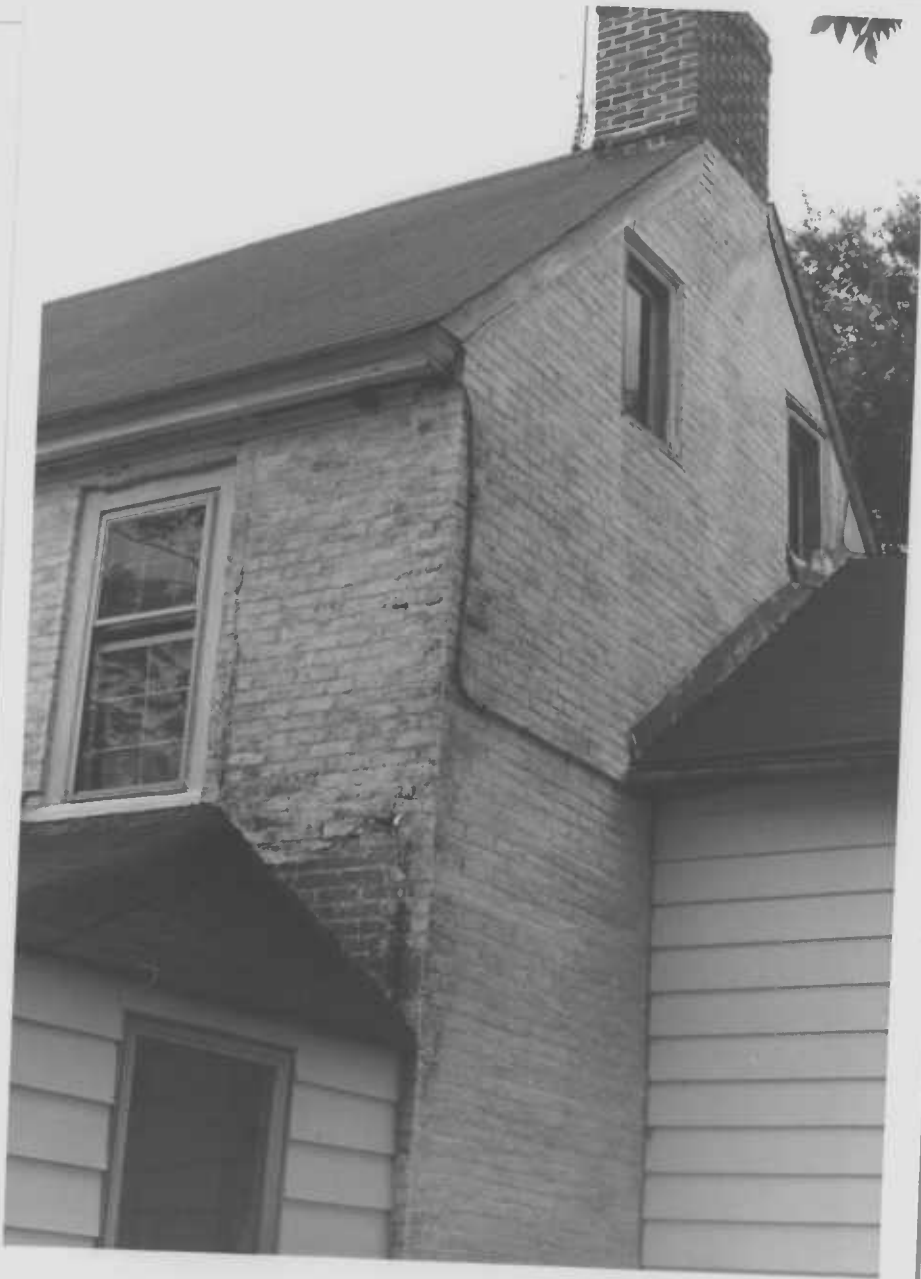
NORTH ELEVATION OF REAR WING

The west side is obviously covered primarily by the earlier rear section. The common bond structure is two bays across with an entrance in between the two 6/9 sash windows. 6/9 sash are also found to light the second floor with an thumb and astragal backband. The window frames are of mortise and tenon construction. A boxed cornice covers the rafter ends above the second floor windows and is embellished with a cymarecta curve crown molding and a bed molding as well.

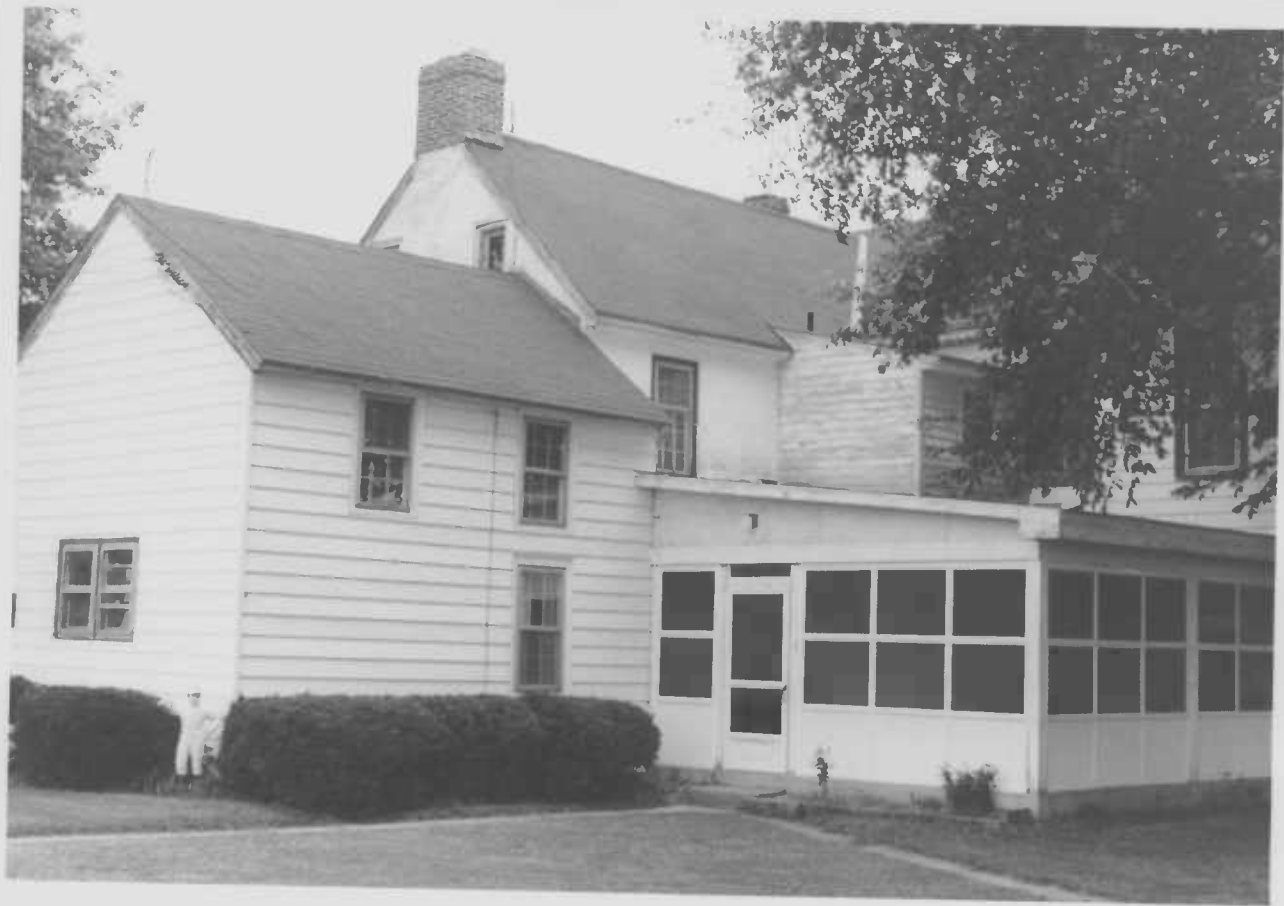
SOUTHWEST ELEVATION

The west gable end is partially covered with a later 1½ story frame addition. Two attic windows do flank the interior brick stack but have lost their moveable sash and are presently single pane. A backband with thumb and astragal molding does remain.

The south side is also predominantly covered with later frame additions. The first floor door between the two windows has been partially closed. Similar molding are also found on these openings.

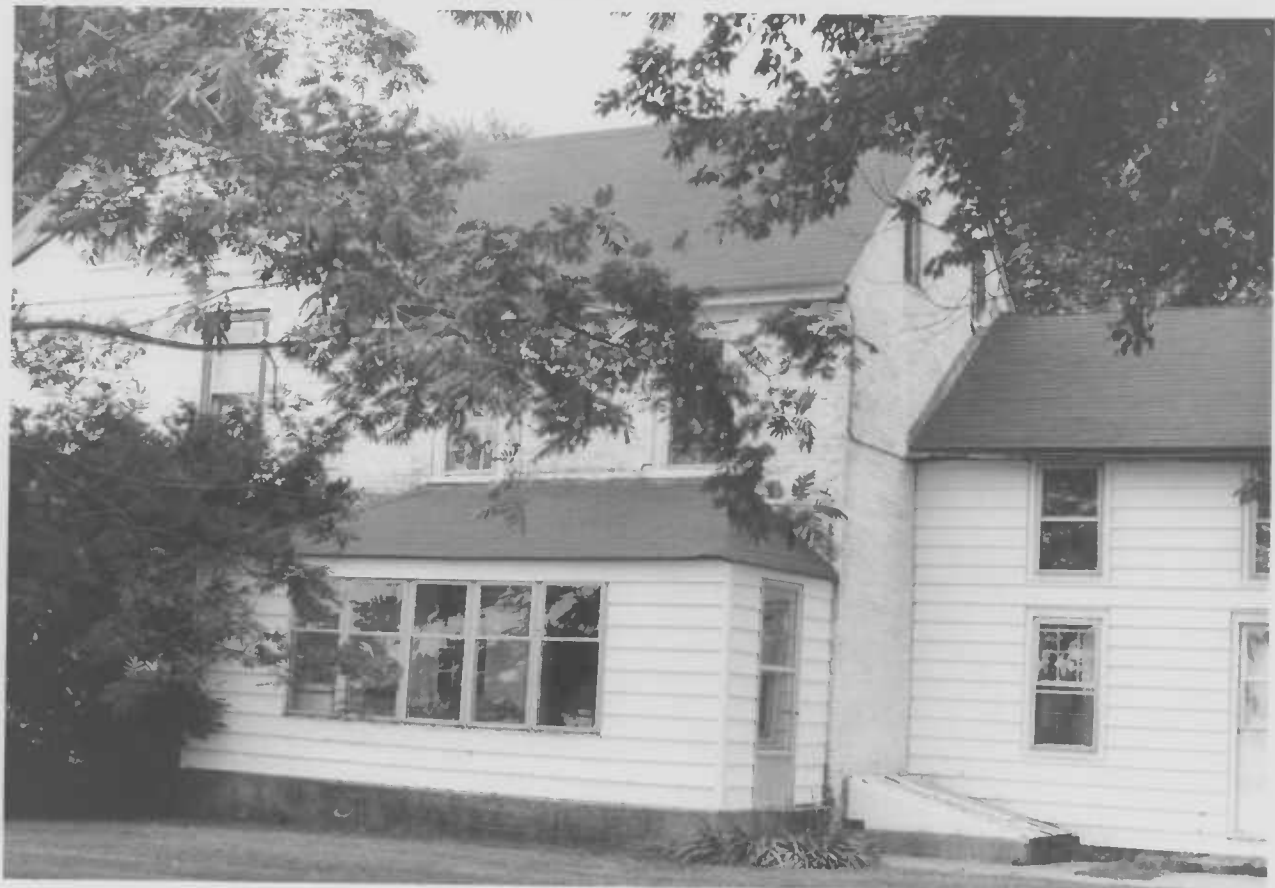
NORTH ELEVATION

The north and south gable end have single 2/2 sash windows on each floor and two four pane attic lights that flank the interior end brick stove stacks.
